Test Report

No. 10102548/07

Sample Description : Paste Flux PoP707
Sample Receiving Date : 28 September 2007
Testing Period : 29 September 2007 to 03 October 2007
Test Requested : To determine the halogen contents on the submitted sample.

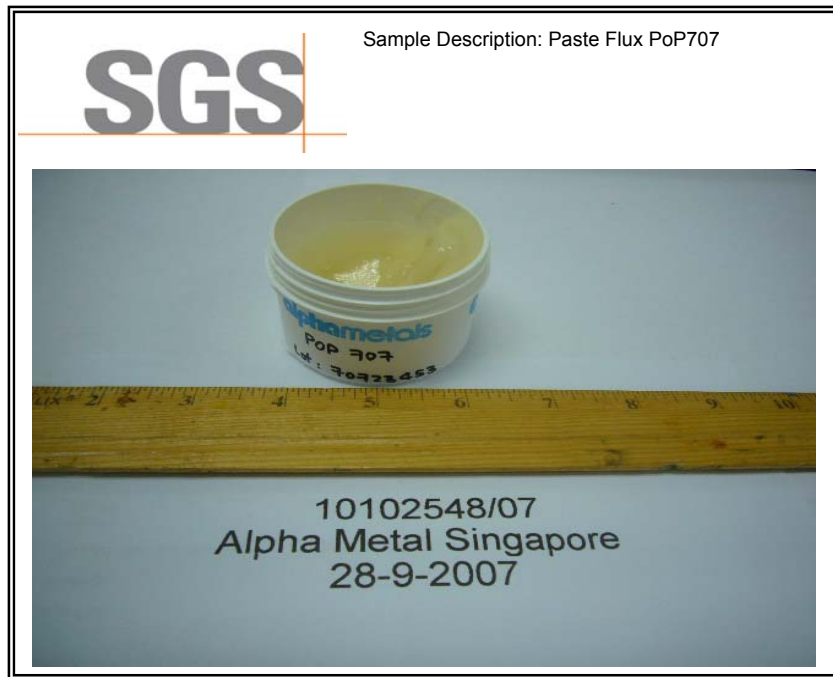
Sample photo:

Sample Description : Paste Flux PoP707
